## Thermal Imaging Tests on Generator Set Systems

Information Sheet # 42

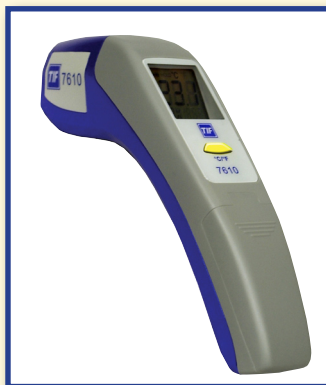
Infrared Ray Gun

Many service technicians use infrared guns, which show any such hot spots but these are unable to provide a hard copy for the record. Today's thermal imagers have ability to view live images of heat emitted from equipment and are becoming ever more affordable, making them highly practical and cost-effective. *(Continued over)*

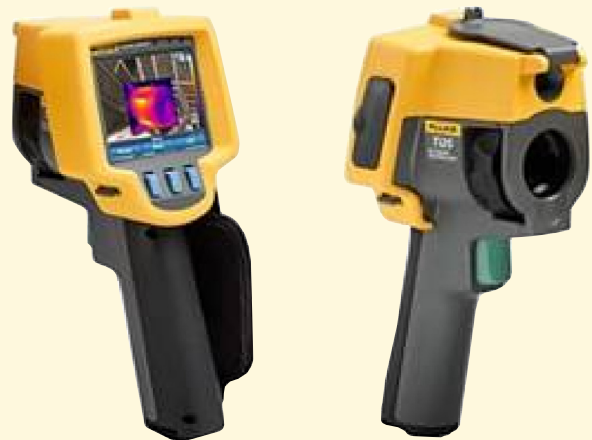
Images of an Actual Infrared Camera

The technician points the imager at the equipment in question, scans the immediate area for unexpected hot spots, then squeezes the trigger to capture a specific image. Once the inspection has been completed, the saved images can be uploaded to a computer for closer analysis, reporting or future trending. While imagers are simple to operate, they are most effectively employed when in the hands of a qualified technician, who understands electrical measurement and the equipment being inspected.
